**Qualitative On-Roof
Roof Moisture
Infrared Thermographic Survey
Of
Industrial Services Inc.
At
Building Material Center
For
Mr. Smith
December 1, 2014**

Roof Moisture Survey on December 1, 2014

Construction Central
Building Material Center
Big City, TX 80225

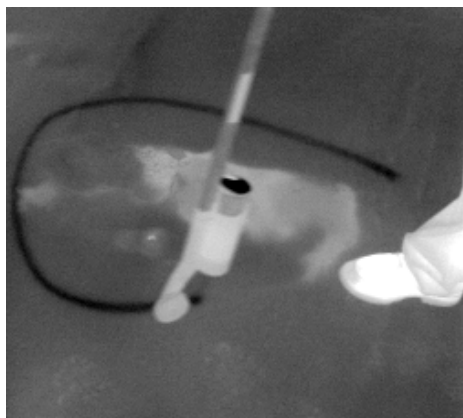
Suspect wet areas marked directly on the roof with marking paint.

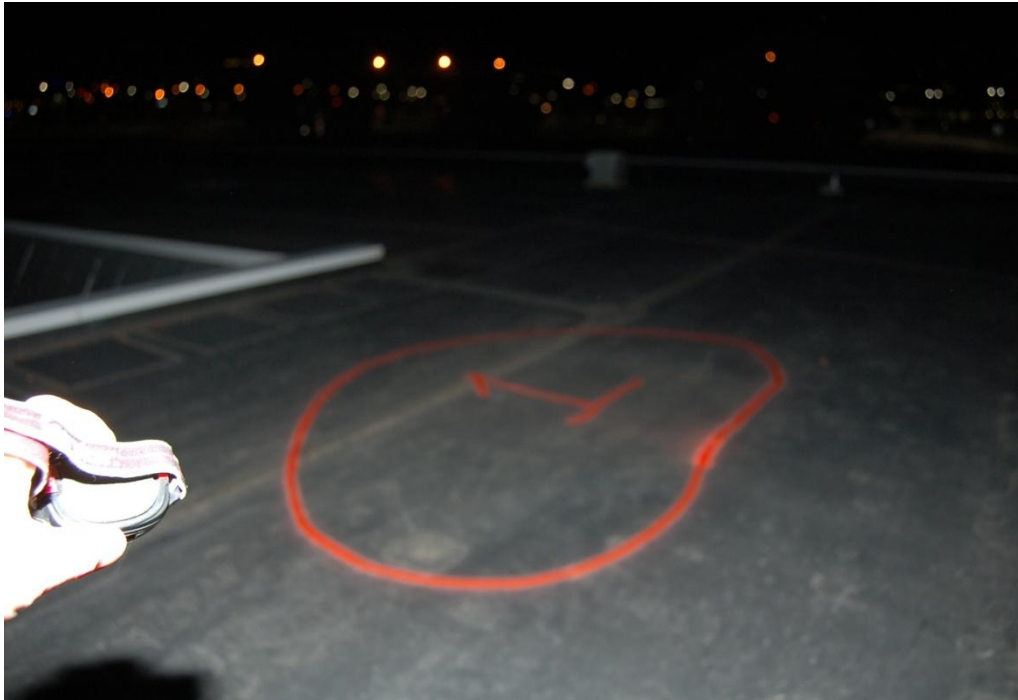
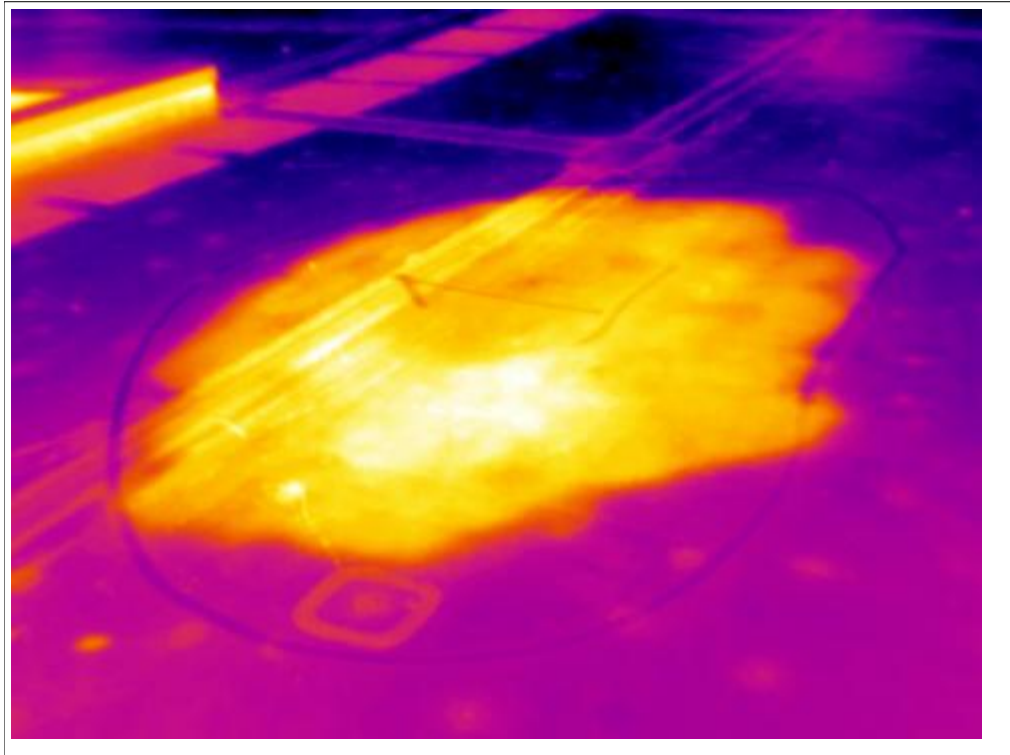
Notes: Probable wet area marked directly on the roof

We recommend that your roof maintenance team carefully review this report. Then, with reference to the images contained herein and the marked areas on the roof, these areas should be physically located and given a thorough visual examination. When warranted, these areas should be subjected to a destructive test (core sample) to confirm the analysis. We recommend a roofing profession conduct core samples on the roof(s) as needed. Destructive probes and roof cores will be taken and repaired by others and are not in this scope of our work. Services

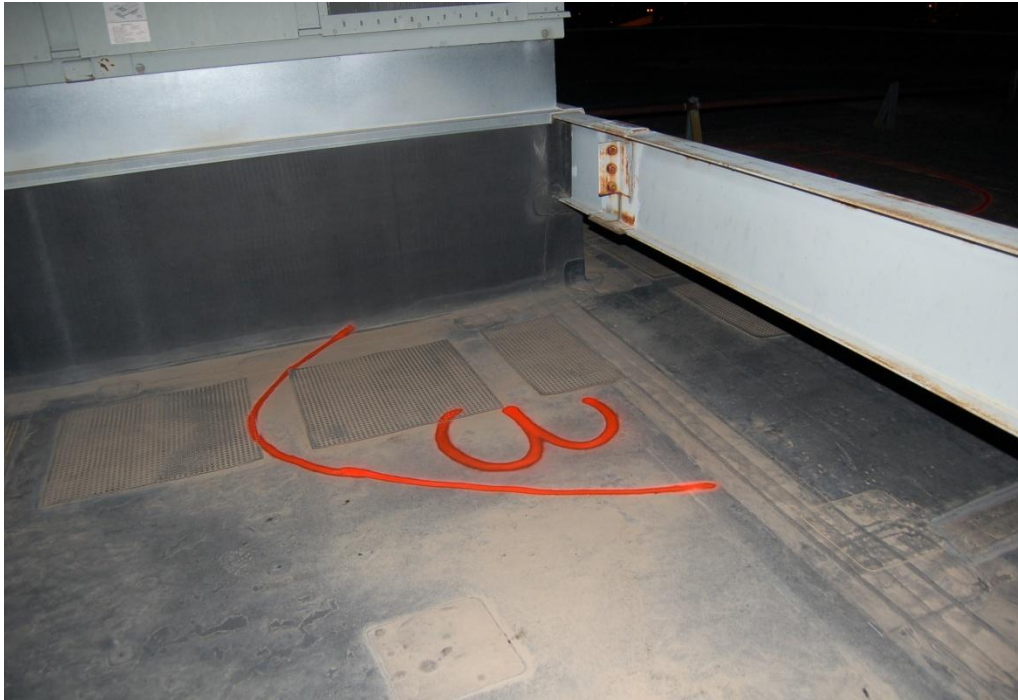
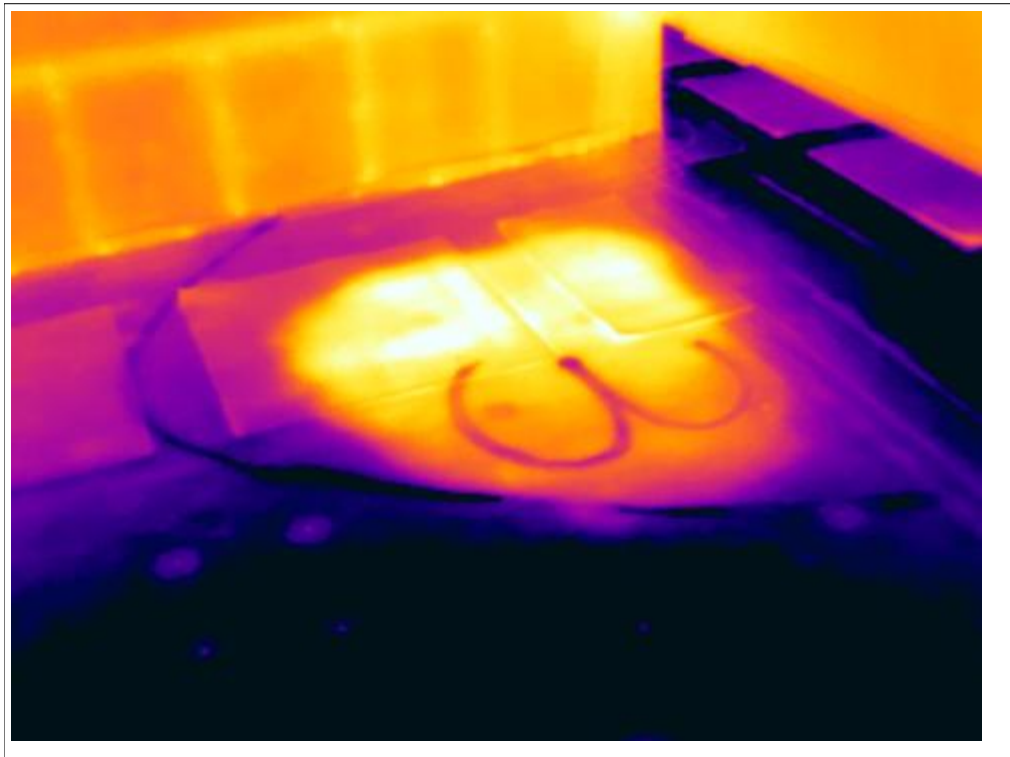
Notes: Probable wet area marked directly on the roof

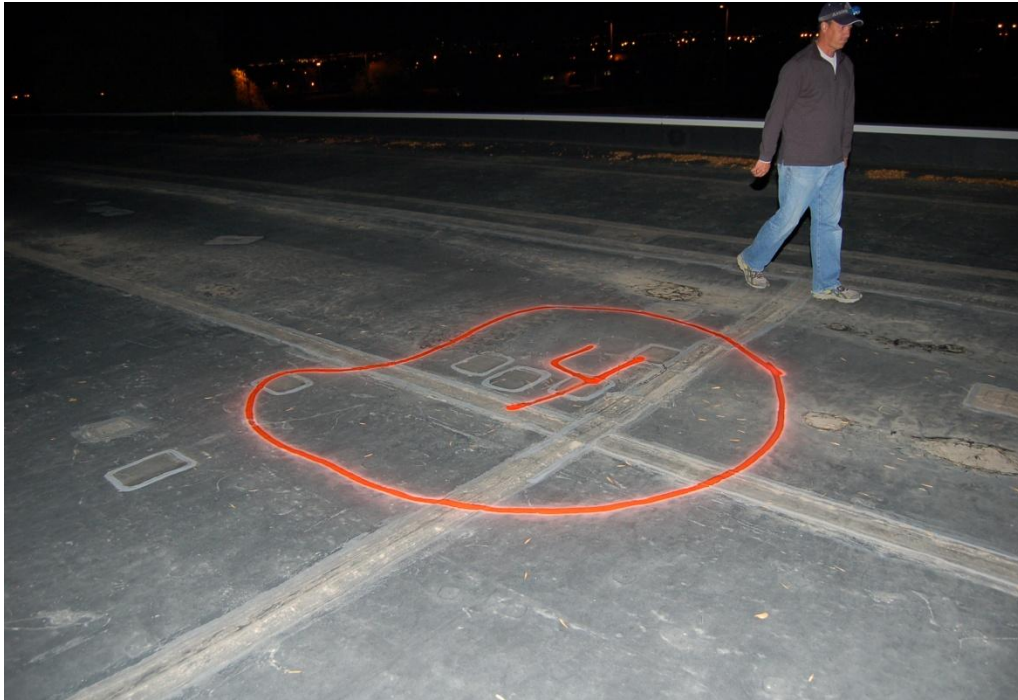
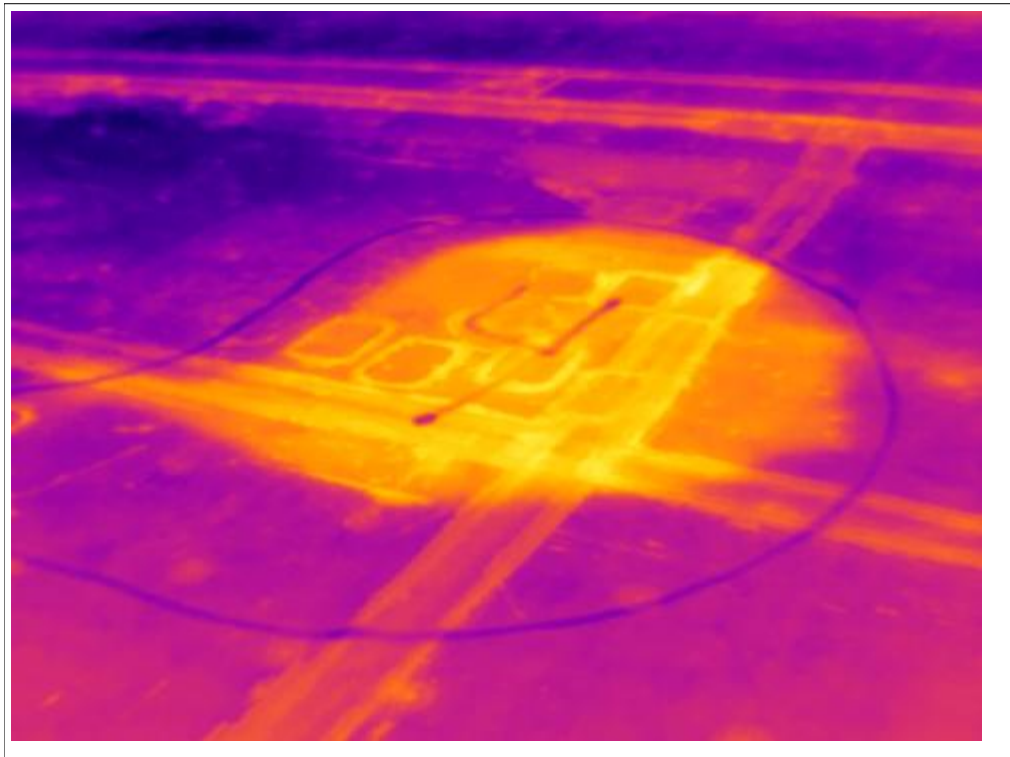
Notes: Probable wet area marked directly on the roof

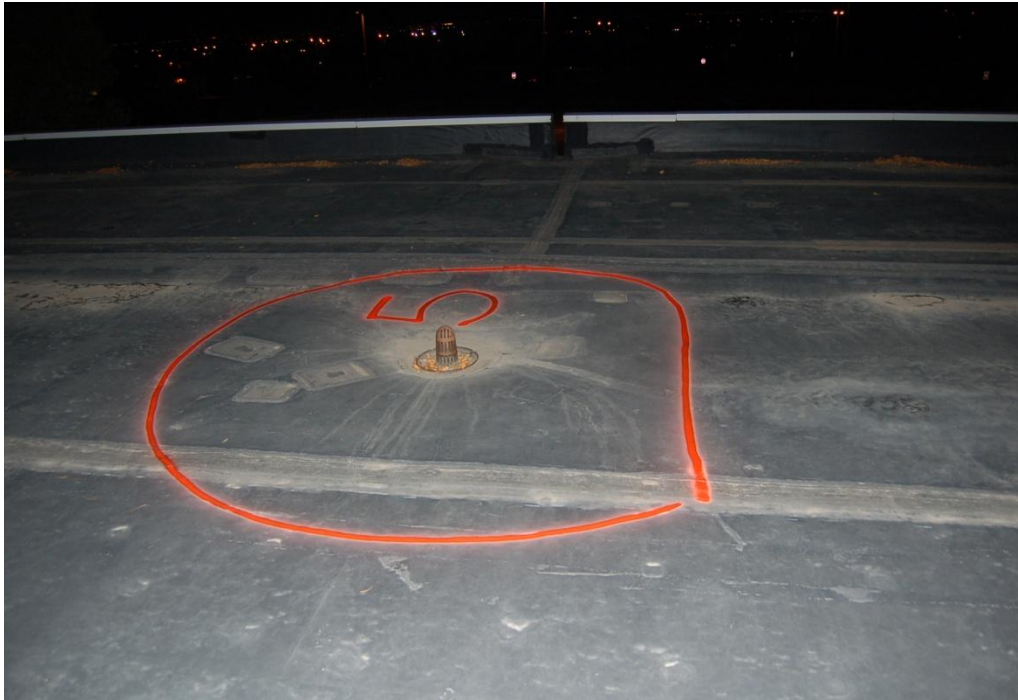
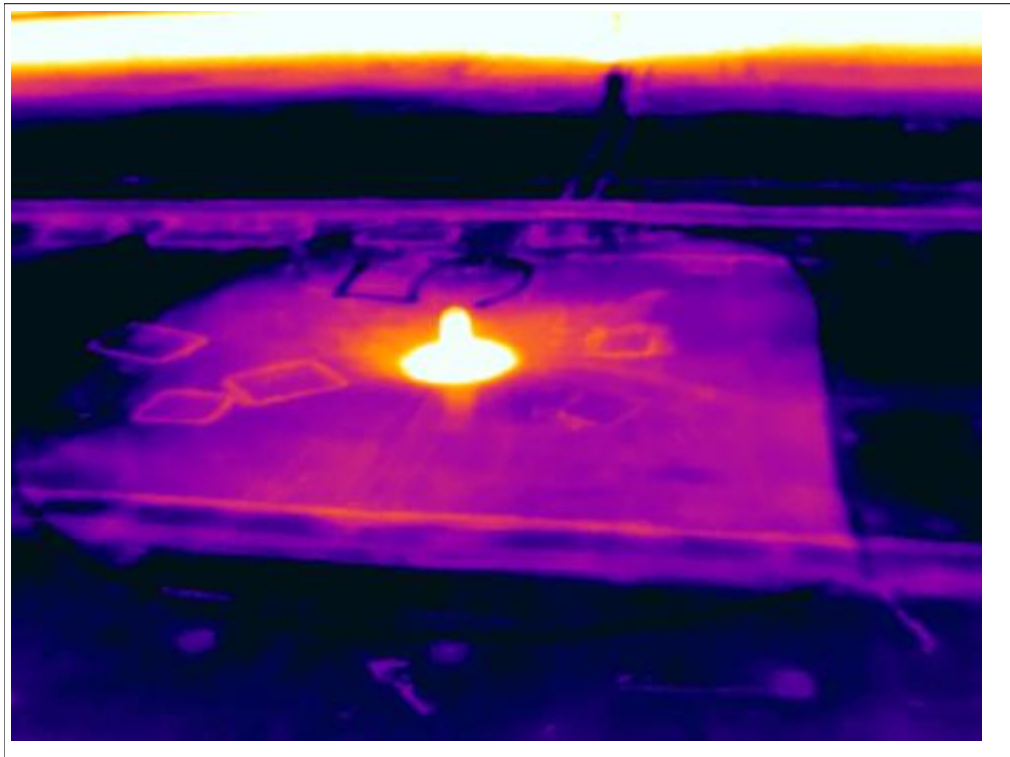
Notes: Probable wet area marked directly on the roof
