A Qualitative Infrared Thermographic Survey of Electrical Equipment

**Memorial Industrial AI
1234 Smith Avenue B
Houston, Texas**

Project #: 25e060

July 25, 2025

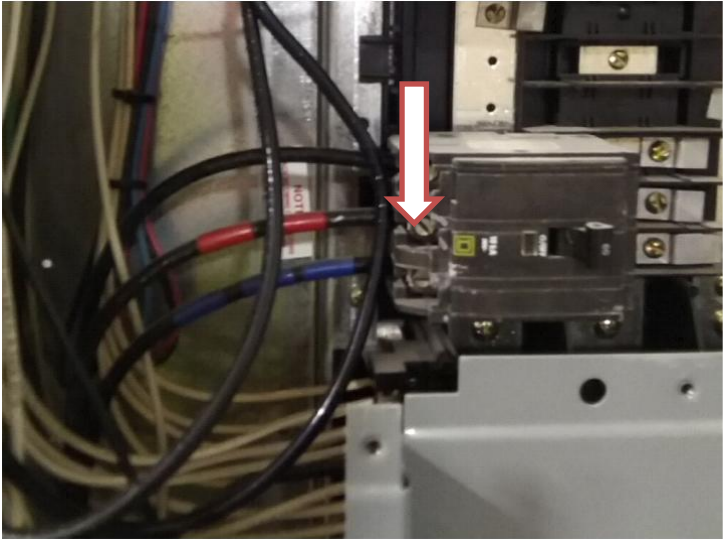
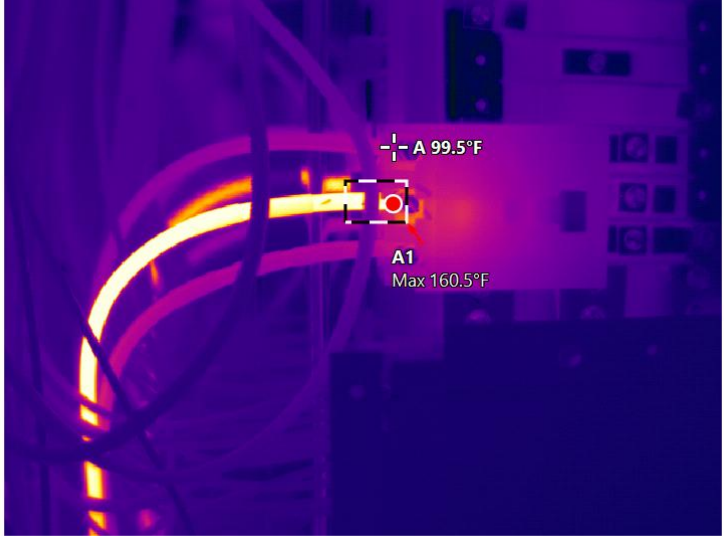
<p>Report # 1</p> <p>Client: Memorial Industrial AI</p> <p>Building: Memorial Industrial AI</p> <p>Location of Findings:</p> <p>Basement 2 Panel L Main breaker</p>

<p>Time: 05/28/2025 11:09 AM</p> <p>File name: FOTRIC_05-28-2025_1258</p> <table border="1" style="width: 100%; border-collapse: collapse; margin-top: 10px;"> <tr> <td style="padding: 2px;">Ambient</td> <td style="padding: 2px;">77.0°F</td> </tr> <tr> <td style="padding: 2px;">Emissivity</td> <td style="padding: 2px;">0.95</td> </tr> </table> <table border="1" style="width: 100%; border-collapse: collapse; margin-top: 10px;"> <tr> <td style="padding: 2px;">Area</td> <td style="padding: 2px;">160.5°F</td> </tr> <tr> <td style="padding: 2px;">Reference</td> <td style="padding: 2px;">99.5°F</td> </tr> <tr> <td style="padding: 2px;">Difference</td> <td style="padding: 2px;">61.0°F</td> </tr> <tr> <td style="padding: 2px;">Rating</td> <td style="padding: 2px;">Serious</td> </tr> </table>	Ambient	77.0°F	Emissivity	0.95	Area	160.5°F	Reference	99.5°F	Difference	61.0°F	Rating	Serious

Ambient	77.0°F												
Emissivity	0.95												
Area	160.5°F												
Reference	99.5°F												
Difference	61.0°F												
Rating	Serious												
<p>Finding: Check load and connections, replace/repair as needed.</p>

Rating	Temperature Rise in F°	Recommendation
Minor	1-15 °F	Routine, Repair during regular maintenance, little chance of physical damage.
Alert	16-50 °F	Repair within 30 days, watch load and inspect for physical damage.
Serious	51-100 °F	Repair/Replace ASAP. Inspect surrounding components for physical damage.
Critical	100+ °F	Immediate repair/replace. Danger exists!

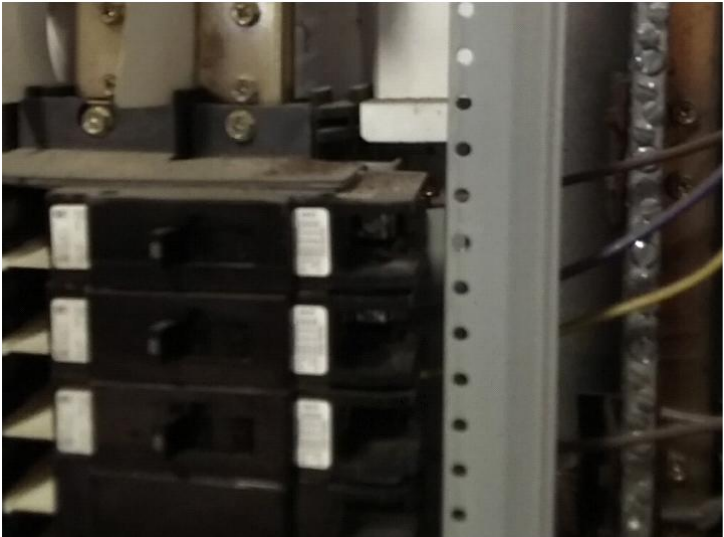
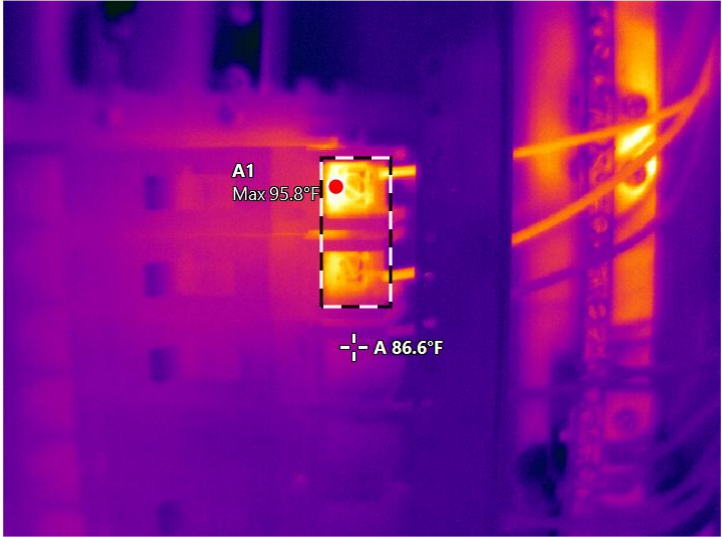
<p>Report # 2</p> <p>Client: Memorial Industrial AI</p> <p>Building: Memorial Industrial AI</p> <p>Location of Findings:</p> <p>Main hall Panel WH Breaker 2/4</p>

<p>Time: 05/28/2025 12:18 PM</p> <p>File name: FOTRIC_05-28-2025_1264</p> <table border="1" style="width: 100%; border-collapse: collapse; margin-top: 10px;"> <tr> <td style="width: 20%;">Ambient</td> <td>80.6°F</td> </tr> <tr> <td>Emissivity</td> <td>0.95</td> </tr> </table> <table border="1" style="width: 100%; border-collapse: collapse; margin-top: 10px;"> <tr> <td style="width: 20%;">Area</td> <td>95.8°F</td> </tr> <tr> <td>Reference</td> <td>86.6°F</td> </tr> <tr> <td>Difference</td> <td>9.2°F</td> </tr> <tr> <td>Rating</td> <td>Minor</td> </tr> </table>	Ambient	80.6°F	Emissivity	0.95	Area	95.8°F	Reference	86.6°F	Difference	9.2°F	Rating	Minor

Ambient	80.6°F												
Emissivity	0.95												
Area	95.8°F

Reference	86.6°F												
Difference	9.2°F												
Rating	Minor												
<p>Finding: Check load and connections, replace/repair as needed.</p>

Rating	Temperature Rise in F°	Recommendation
Minor	1-15 °F	Routine, Repair during regular maintenance, little chance of physical damage.
Alert	16-50 °F	Repair within 30 days, watch load and inspect for physical damage.
Serious	51-100 °F	Repair/Replace ASAP. Inspect surrounding components for physical damage.
Critical	100+ °F	Immediate repair/replace. Danger exists!

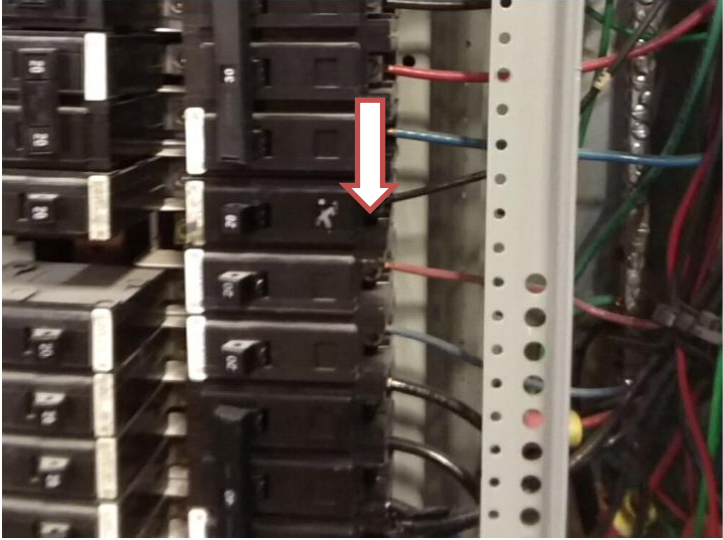
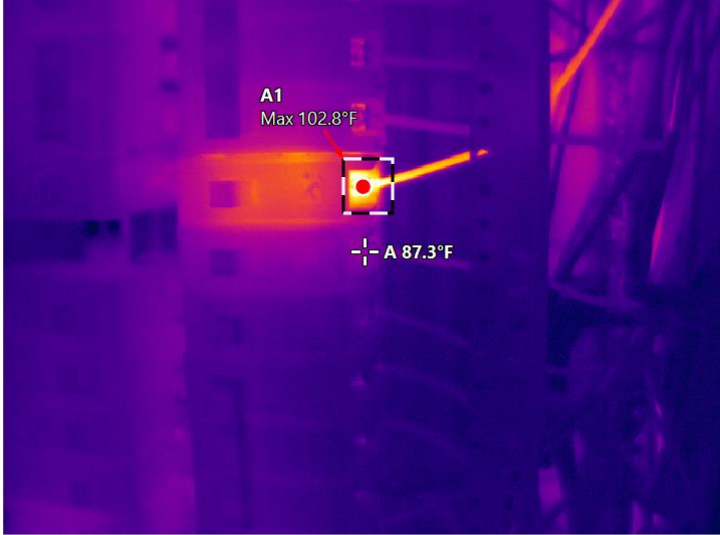
<p>Report # 3</p> <p>Client: Memorial Industrial AI</p> <p>Building: Memorial Industrial AI</p> <p>Location of Findings:</p> <p>Main hall Panel WL Breaker 26</p>

<p>Time: 05/28/2025 12:24 PM</p> <p>File name: FOTRIC_05-28-2025_1266</p> <table border="1" style="width: 100%; border-collapse: collapse; margin-top: 10px;"> <tr> <td style="padding: 2px;">Ambient</td> <td style="padding: 2px;">80.6°F</td> </tr> <tr> <td style="padding: 2px;">Emissivity</td> <td style="padding: 2px;">0.95</td> </tr> </table> <table border="1" style="width: 100%; border-collapse: collapse; margin-top: 10px;"> <tr> <td style="padding: 2px;">Area</td> <td style="padding: 2px;">102.8°F</td> </tr> <tr> <td style="padding: 2px;">Reference</td> <td style="padding: 2px;">87.3°F</td> </tr> <tr> <td style="padding: 2px;">Difference</td> <td style="padding: 2px;">15.5°F</td> </tr> <tr> <td style="padding: 2px;">Rating</td> <td style="padding: 2px;">Alert</td> </tr> </table>	Ambient	80.6°F	Emissivity	0.95	Area	102.8°F	Reference	87.3°F	Difference	15.5°F	Rating	Alert

Ambient	80.6°F												
Emissivity	0.95												
Area	102.8°F												
Reference	87.3°F												
Difference	15.5°F												
Rating	Alert												
<p>Finding: Check load and connections, replace/repair as needed.</p>

Rating	Temperature Rise in F°	Recommendation
Minor	1-15 °F	Routine, Repair during regular maintenance, little chance of physical damage.
Alert	16-50 °F	Repair within 30 days, watch load and inspect for physical damage.
Serious	51-100 °F	Repair/Replace ASAP. Inspect surrounding components for physical damage.
Critical	100+ °F	Immediate repair/replace. Danger exists!
